QUINNIPIAC RIVER BASIN  
MERIDEN, CONNECTICUT

# BLACK POND DAM CT 00135

## PHASE I INSPECTION REPORT NATIONAL DAM INSPECTION PROGRAM

FEBRUARY, 1981

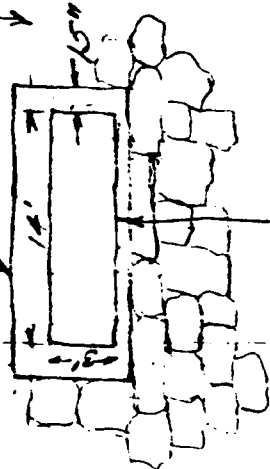
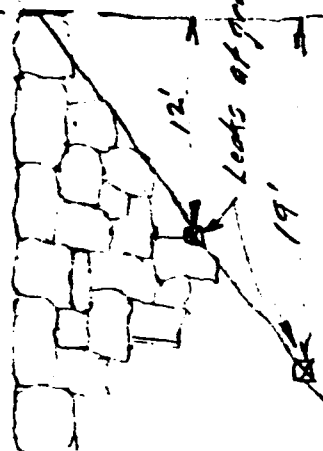
Downstream Elevation of Dam.

Leak thru dam are on west  
side of spillway - at ground surface  
and about 10'-12' below top of  
dam.

Valley at downstream  
face of dam is filled with  
brush and rubbish - may be  
more leaks thru masonry.  
not visible.

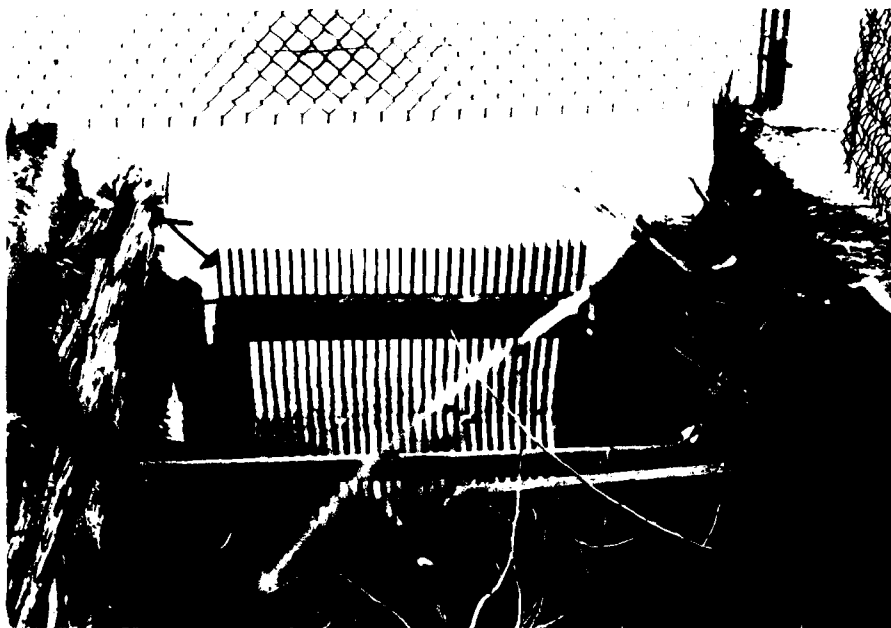
PHOTO 7  
INLET STRUCTURE - WATER MAIN

There is a mortared stone masonry gate inlet structure next to the spillway on the upstream side of the embankment (Photo 7). The structure is poorly fenced and can be entered. There is a bar rack at the inlet and a manually operated gate. The gate controls a 20-inch cast iron water main that is no longer used for water supply. A leak exists near the downstream face where the pipe passes through the dam. The pipe continues along the downstream channel and connects to the City's distribution system.
